City of Abbotsford  
Mill Lake Park Master Plan  
2025

## 3 Site Analysis

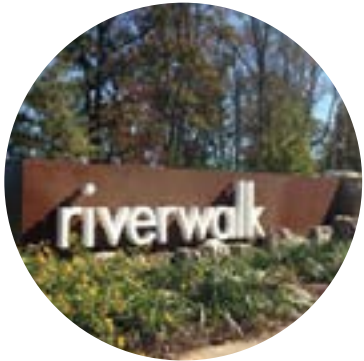
The west entry to the Park from Emerson Street provides the best treatment as a Park entry, incorporating high quality materials and an accessible route into the Park.

Elements to be considered for the Park entrances include:

- Park identification signage
- Wayfinding signage
- Regulatory signage
- Accessible pathways
- Lighting
- Site furnishings

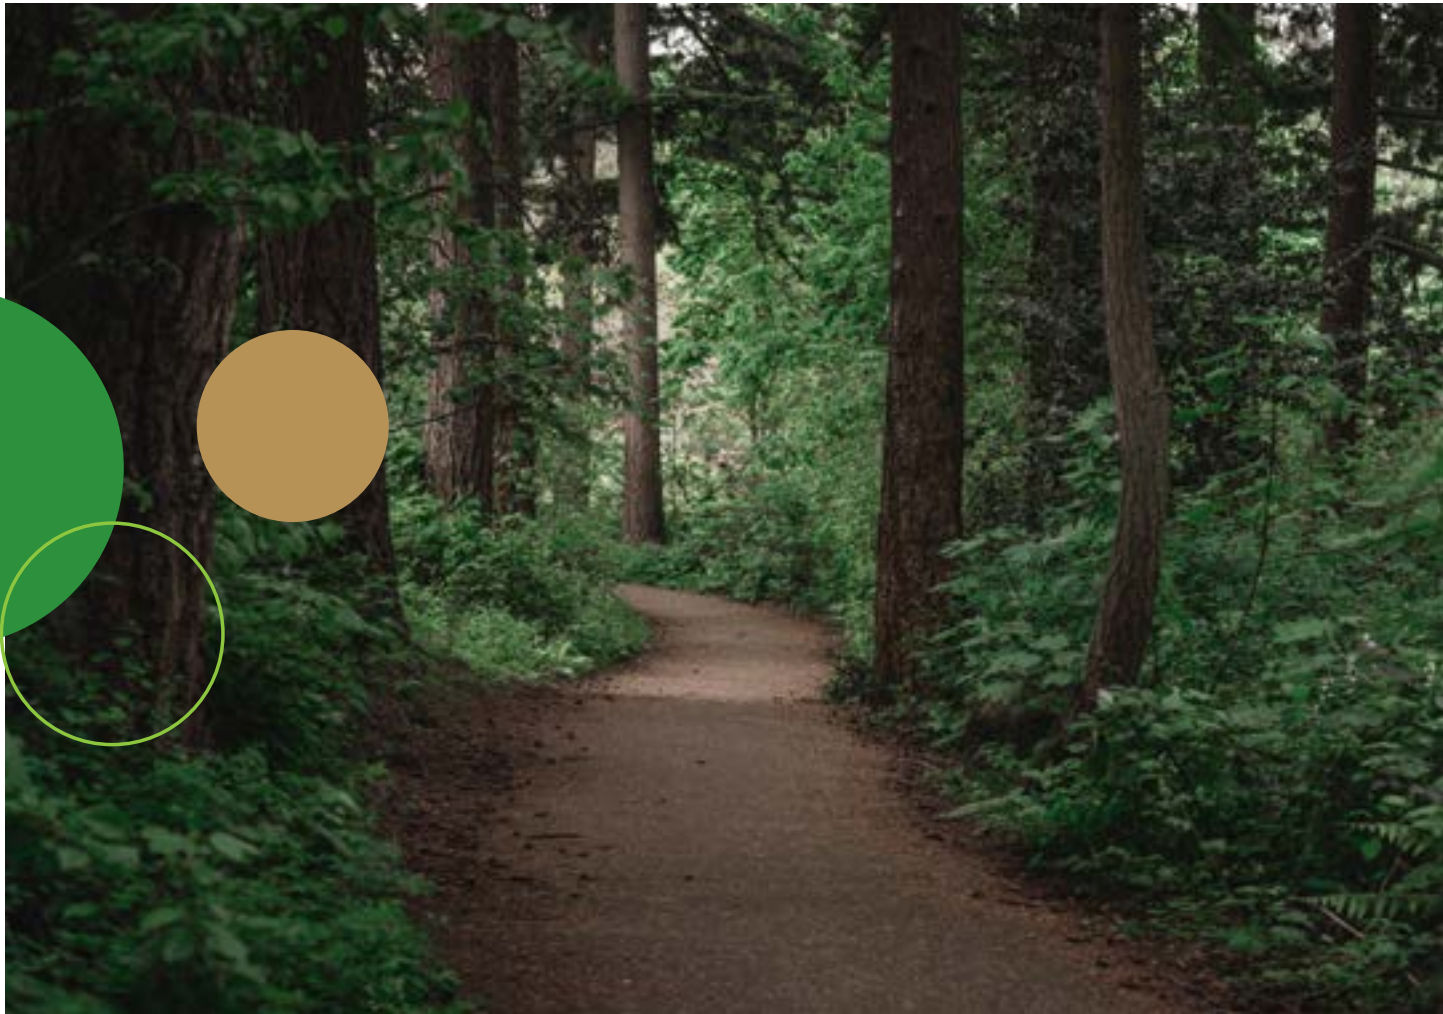
BCCDC mapping was used to identify previously recorded known occurrences of species and ecosystems at risk on or within 1km of Mill Lake Park.

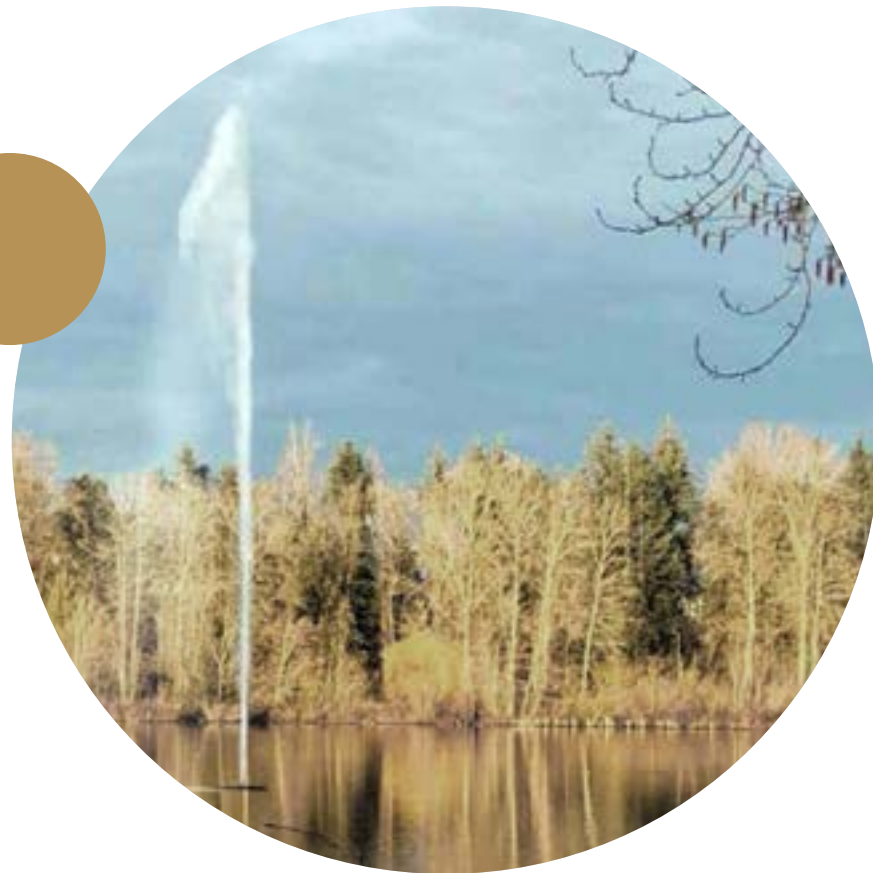
### 3.7.3 Lake Fountain Including Power Service Upgrade to Park

In 2019, the City established a Mill Lake Park Reserve Fund and received a notable donation for improvements to the Park. The first capital improvement using these funds was authorized by Council to be an aeration fountain to improve the water quality of Mill Lake, and in turn the surrounding ecosystem, and to provide a beautiful aesthetic addition to the City's premier Park.

The fountain, installed in 2022, sprays lake water 30 metres into the air and has LED lighting to allow colours to be changed as desired.

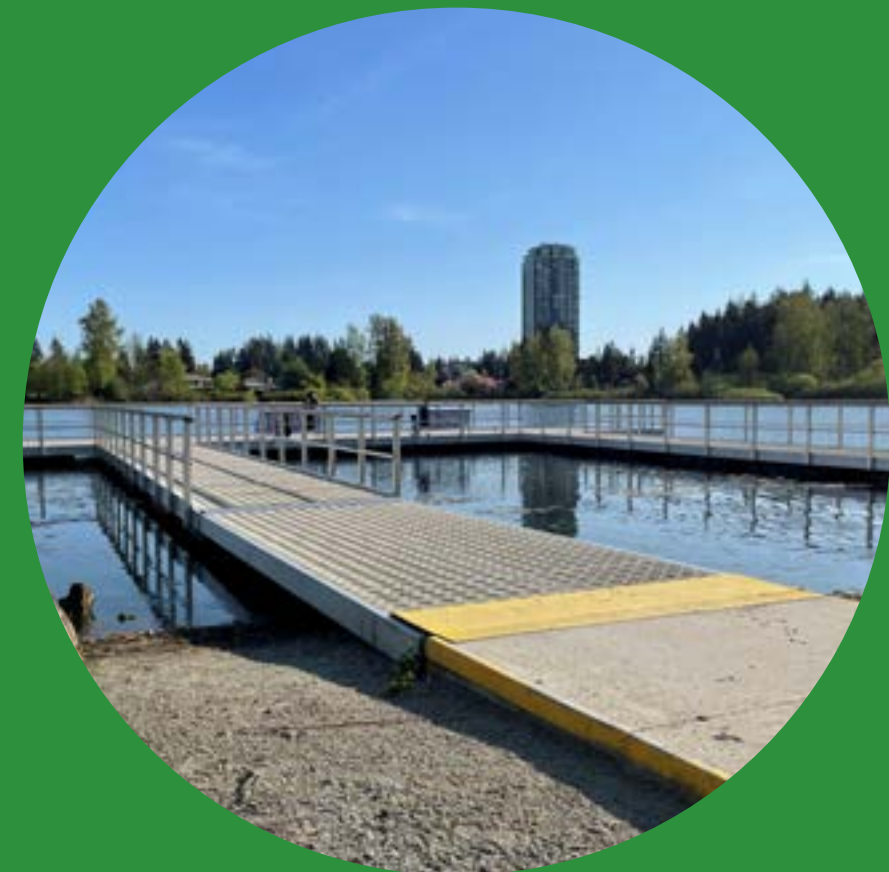
### 3.7.4 Reconstruction of Dock

A nature observation and fishing dock was constructed and installed in 2022. The floating dock is rectangular and measures 22 metres long x 5 metres wide with twin 2.5 metre wide pedestrian access walkways. The floating dock features lightweight, environmentally friendly, aluminum construction, an accessible design and guardrails to help ensure a safe and enjoyable visit for all.
